Manhole Inspection Summary

Manhole # S31GG_014MH

Location Address: **215 BOLTON PL**

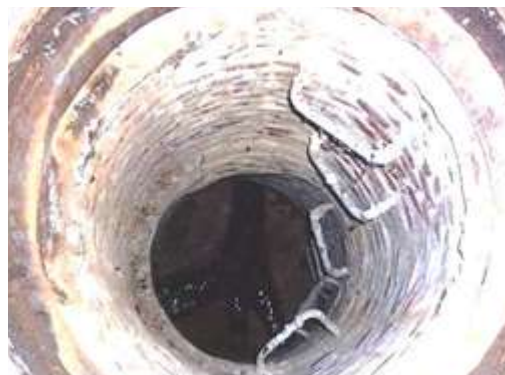
Top View

Barrel infiltration. Bench debris.

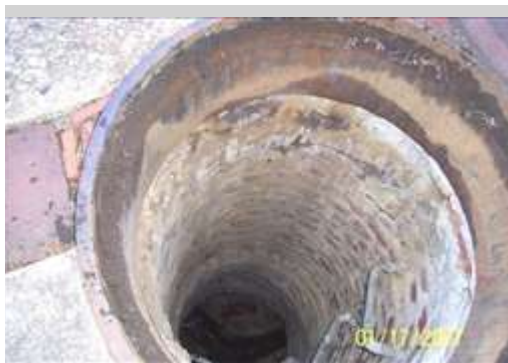
Defect

Adjustment deterioration and infiltration.
Corbel infiltration - other side.

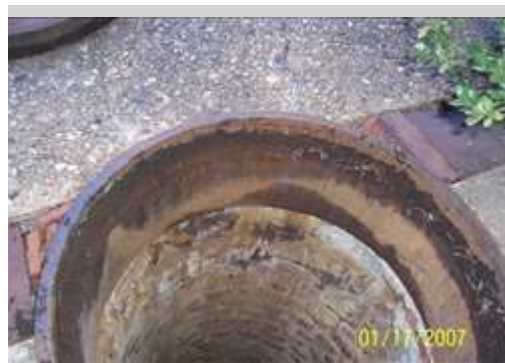
Defect

Adjustment deterioration and infiltration.
Corbel infiltration.

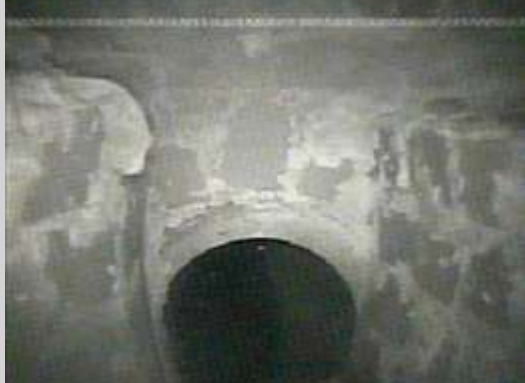
Pipe Out @ 12 O'Clock

8 in. Circular Gravity Sewer

Pipe Material: **Clay** ☐ Pipe Lined

Invert Depth: **16.10** (ft.) Flow Characteristics: **Fast**

Deposits: ☒ None ☐ Mud ☐ Sludge ☐ Debris ☐ Grease

Infiltration: **None** Pipe Seal Cond: **Unknown**

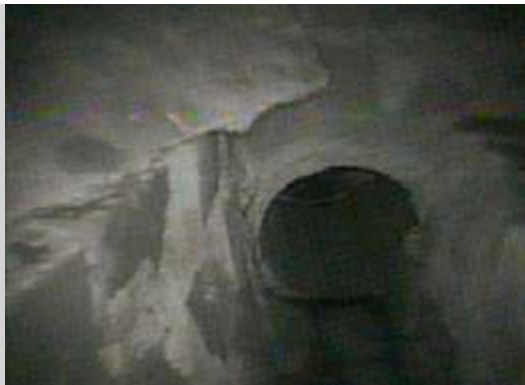
Pipe In @ 5 O'Clock

6 in. Circular Gravity Sewer

Pipe Material: **Clay** ☐ Pipe Lined

Invert Depth: **15.25** (ft.) Flow Characteristics: **Slow**

Deposits: ☒ None ☐ Mud ☐ Sludge ☐ Debris ☐ Grease

Infiltration: **None** Pipe Seal Cond: **Unknown**

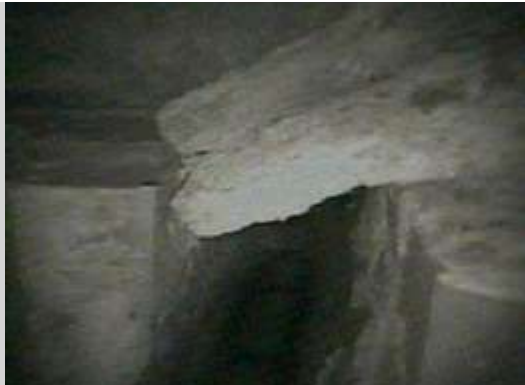
Pipe In @ 6 O'Clock

8 in. Circular Gravity Sewer

Pipe Material: **Clay** ☐ Pipe Lined

Invert Depth: **15.20** (ft.) Flow Characteristics: **Slow**

Deposits: ☒ None ☐ Mud ☐ Sludge ☐ Debris ☐ Grease

Infiltration: **None**

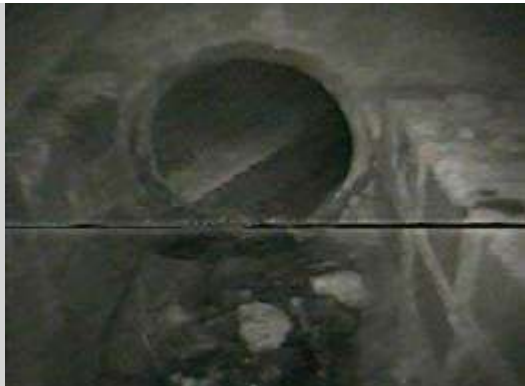
Pipe In @ 8 O'Clock

8 in. Circular Gravity Sewer

Pipe Material: **Clay** ☐ Pipe Lined

Deposits: ☐ None ☐ Mud ☐ Sludge ☒ Debris ☒ Grease

Silt Depth: **0** (in.) Deposits Extent: **Light**

Infiltration: **Evidence**
